SPINDLE KEYWAY INTERFERENCE WITH AXLE FASTENER TANG

STEMCO HAS BEEN NOTIFIED OF AN INTERFERENCE ISSUE BETWEEN THE ZIP-TORQ OR AUTO-TORQ AXLE FASTENER AND SOME SPINDLE KEYWAYS THAT HAVE BEEN CUT DIFFERENTLY THAN MOST STANDARD APPLICATIONS.

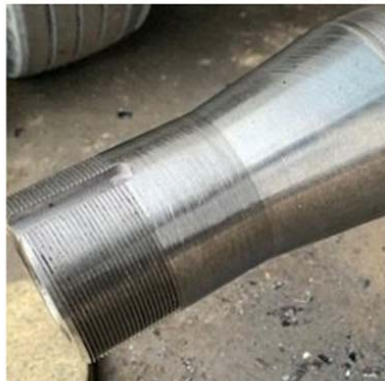
FIGURE 1. KEYWAY PROFILE EXAMPLE 1

The issue arises when the Zip-Torq or Auto-Torq tang “bottoms out” on either the base or the back of the keyway on the spindle. Figure 1 shows an interference example at the back, and Figure 2 shows an interference example at the base. Always check endplay with a dial indicator to ensure 0.001-0.005” is achieved for Zip-Torq or 0.000” is achieved for Auto-Torq. If excessive endplay occurs, first verify that the spindle threads, bearing journals, and seal shoulder are properly cleaned to allow full seating of the wheel end. If excessive endplay persists, there may be interference between the spindle keyway and the tang of the Zip-Torq or Auto-Torq axle fastener.

Keyway is consistent depth throughout, rounded at the back. Contact would be on the corners of the locking tab (and the walls of the keyway)

In the case of interference, STEMCO recommends switching from the Zip-Torq or Auto-Torq axle fastener to the Pro-Torq axle fastener.

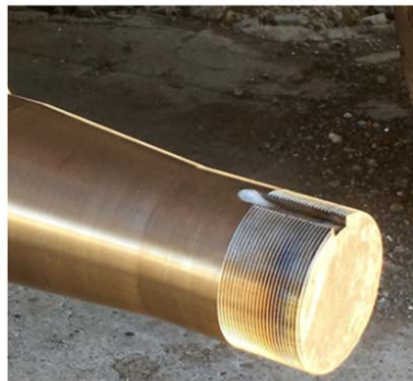
FIGURE 2. KEYWAY PROFILE EXAMPLE 2

Keyway is shallower at the back. Contact would be at the base of the locking tab (and the root of the keyway)
