Tech Tip #43

TECH TIP – "Recommended practice when removing the ¼" nylon air tubing from the Torque Transfer Shaft (TTS) fitting on the Rotary Air Union (RAU)"

Customer: Aeris®

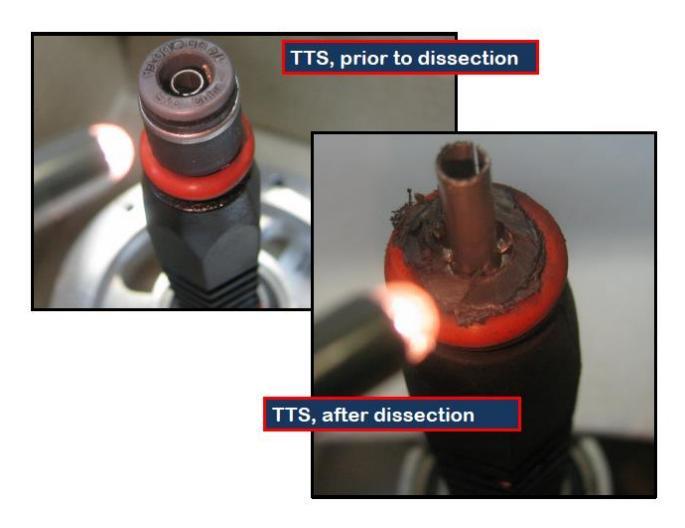
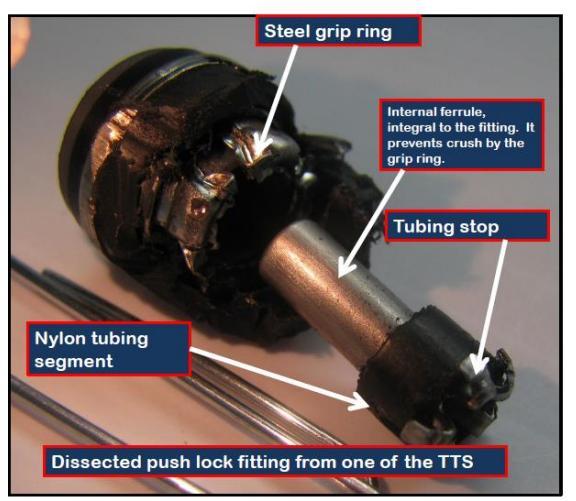
A customer complained that he could not insert the ¼" nylon air tubing into the TTS fitting on the RAU. It was found that excessive pull force was used when removing RAU. A segment of nylon tubing, approximately 0.21" in length, was stuck in the bottom of the connector cavity of the TTS push-lock fitting, preventing installation of new tubing into the TTS.

Figure 1. Torque transfer shaft dissection

- a) Not enough 'slack' in the tubing between the pass-thru fitting and the TTS, therefore, the mechanic could not access the release ring on the push-lock fitting, so he just pulled the RAU assembly until the tubing failed at the grip ring teeth (stress riser).
- b) Failure to release system pressure before attempting to remove the tubing from the fitting. With pressure in the tubing, it is very difficult to depress the release ring to remove the tubing, so the RAU assembly was pulled until the tubing failed at the grip ring teeth.
