ZIP-TORQ® Thread Engagement

ZIP-TORQ® Compatibility Check

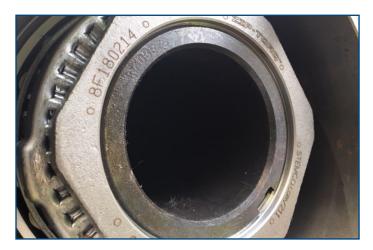
On some applications, commonly the R drive application, the Zip-Torq® axle fastener may appear to protrude past the end of the spindle. As the pictures below reflect, while a slight protrusion is present, all of the visible threads on the Zip-Torq® are engaged. STEMCO has performed extensive testing on the Zip-Torq® thread's in comparison to the Pro-Torq threads. Based on this testing, STEMCO's recommendation is to ensure all visible threads are engaged and the Zip-Torq® will operate normally. The Zip-Torq should not protrude more than 1/8" past the end of the spindle during normal wheel end operation. If you have any further questions please contact a local STEMCO Sales Manager.

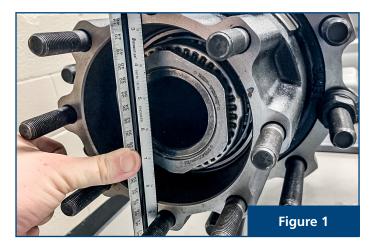
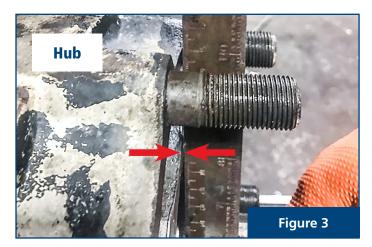
In addition to the above scenario, some hubs when paired with the Zip-Torq®, on R drive application, allow the Zip-Torq® to protrude past the hub face causing interference between the nut face of the Zip-Torq® and the axle shaft flange. The hub face is the mating surface between the hub and the axle shaft flange.

- 1. Place a straight edge across the hub face (See Figure 1)
- 2. If the straight edge does NOT come in contact with the Zip-Torq®, then the Zip-Torq® can be used (See Figure 2)
- 3. If the straight edge does come in contact with the Zip-Torq®, remove the Zip-Torq® and replace with a Pro-Torq® (See Figure 3)

In order to make sure that a Zip-Torq® can be installed with a certain hub, STEMCO recommends the following check after completing the recommended bearing adjustment:
