Identifying a Non-Leaking Seal and Leaking Seal

This Tech Tip is to help customers correctly identify a non-leaking seal and leaking seal to prevent unnecessary down time.

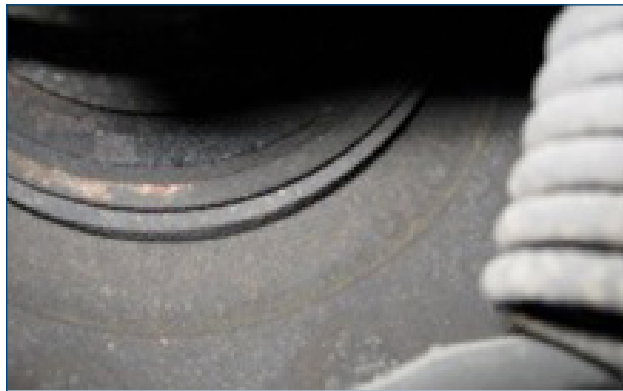
FIGURE 1: Non-Leaking Seal

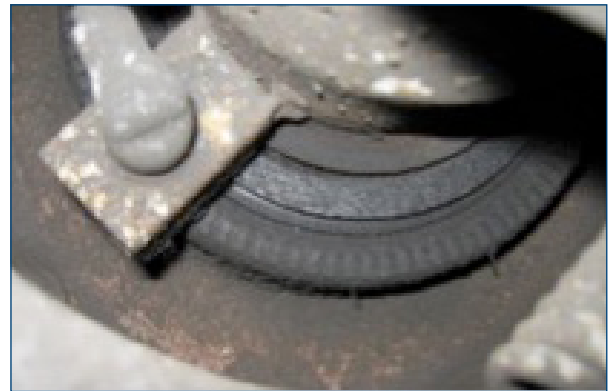
FIGURE 2: Non-Leaking Seal

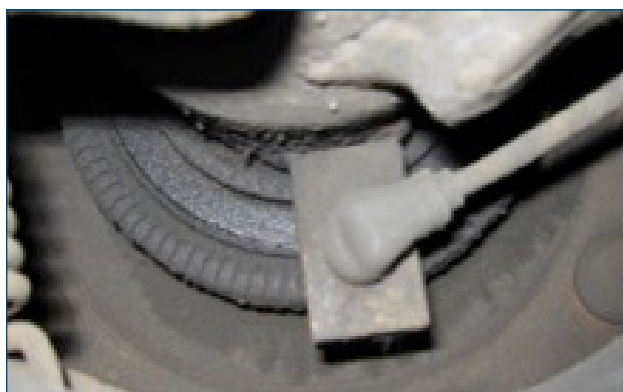
FIGURE 3: Non-Leaking Seal

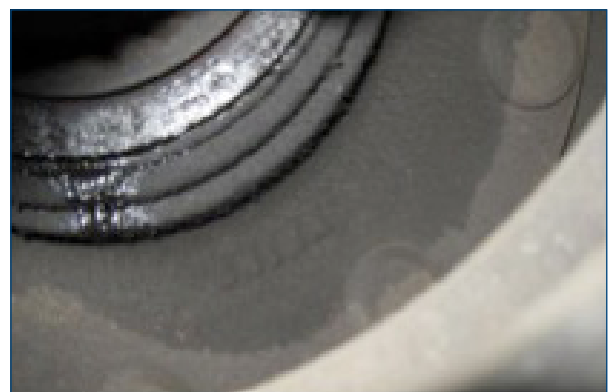
FIGURE 4: Leaking - Change Seal

A small amount of visible lubricant seepage on the backside of STEMCO seals is considered normal and acceptable. We often see this in new seals that we test every day. This is not unusual, and it does not mean that the seal is leaking. This seepage is most likely a result of grease prelube escaping from a newly installed seal. Our factory places this grease prelube into the seal upon assembly to reduce the frictional heat generation upon seal "run-in". If the visible seepage extends well out onto the hub and is quite damp, then the seal may be leaking and should be replaced at the first opportunity.
