**Tech Tip #49**

**Identification of non-leaking seal versus leaking seal**

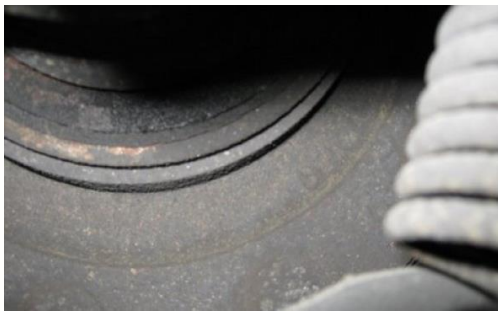
**Figure 1: Non-Leaking Seal**

A small amount of visible lubricant seepage on the backside of Stemco seals is considered normal and acceptable. We often see this in new seals that we test every day. This is not unusual, and it does not mean that the seal is leaking. This seepage is most likely a result of grease prelube escaping from a newly installed seal. Our factory places this grease prelube into the seal upon assembly to reduce the frictional heat generation upon seal “run-in”. If the visible seepage extends well out onto the hub and is quite damp, then the seal may be leaking and should be replaced at the first opportunity.

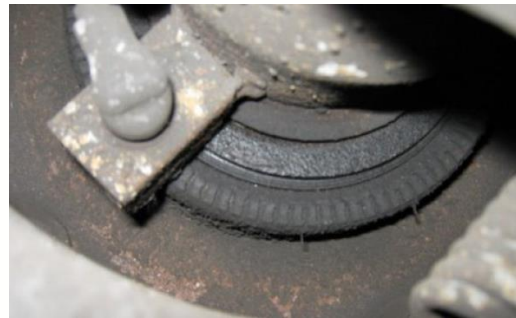
**Figure 2: Non-Leaking Seal**

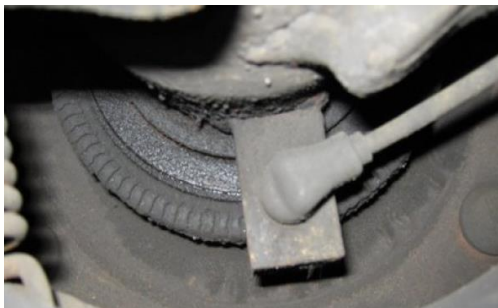
**Figure 3: Non-Leaking Seal**

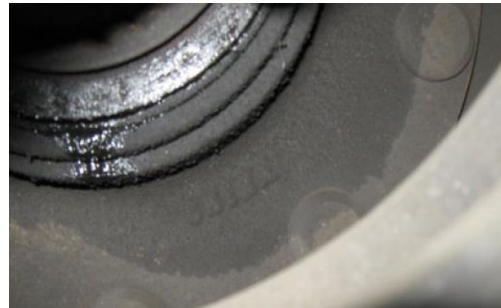
**Figure 4: Leaking – Change Seal**
