ZIP-TORQ® Thread Engagement

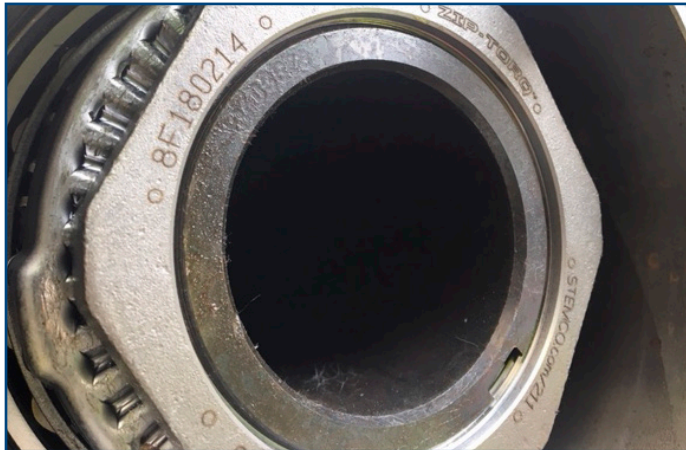
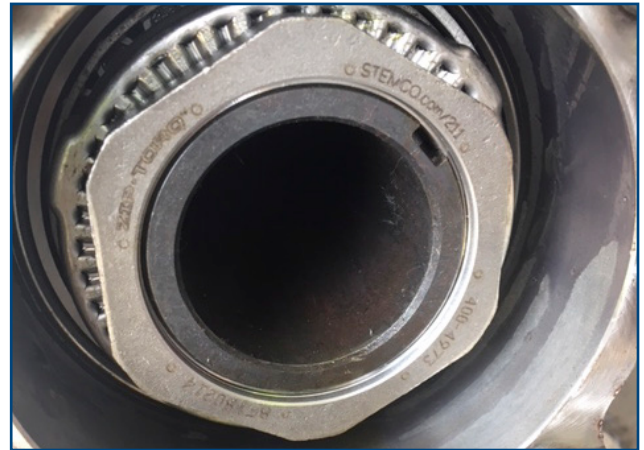
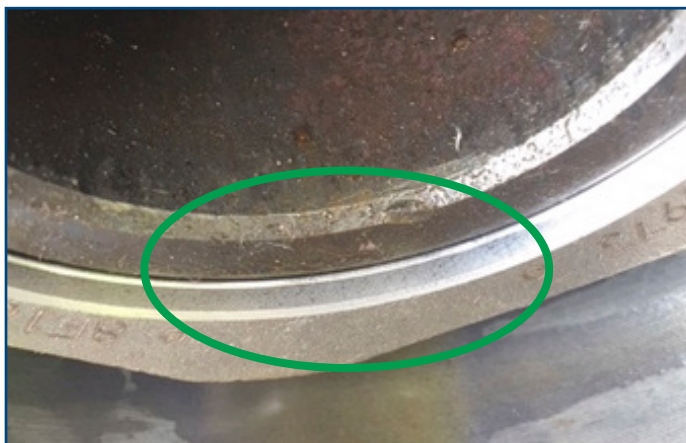
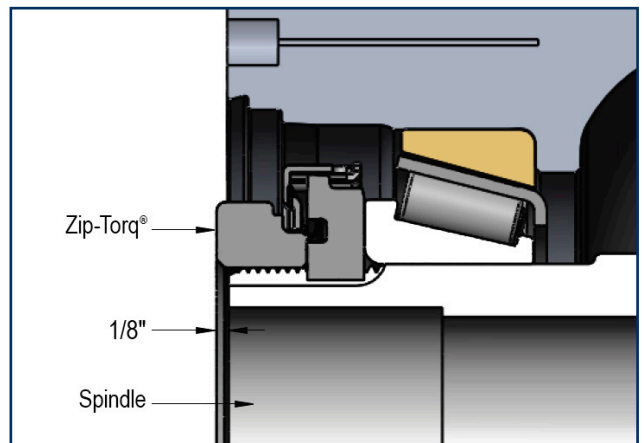
On some applications, commonly the R drive application, the Zip-Torq® axle fastener may appear to protrude past the end of the spindle. As the pictures below reflect, while a slight protrusion is present, all of the visible threads on the Zip-Torq® are engaged. STEMCO has performed extensive testing on the Zip-Torq® thread's in comparison to the Pro-Torq threads. Based on this testing, STEMCO's recommendation is to ensure all visible threads are engaged and the Zip-Torq® will operate normally. The Zip-Torq should not protrude more than 1/8" past the end of the spindle during normal wheel end operation. If you have any further questions please contact a local STEMCO Sales Manager.
